# EPIL TEST REPORT

**Project No.:** L4-60089

**Equipment Under Test:** CATHODIC PROTECTION INTERRUPTER

**Tested According to:** IEC 60529 2013/CORE1: 2019 AND IEC 62208 2011

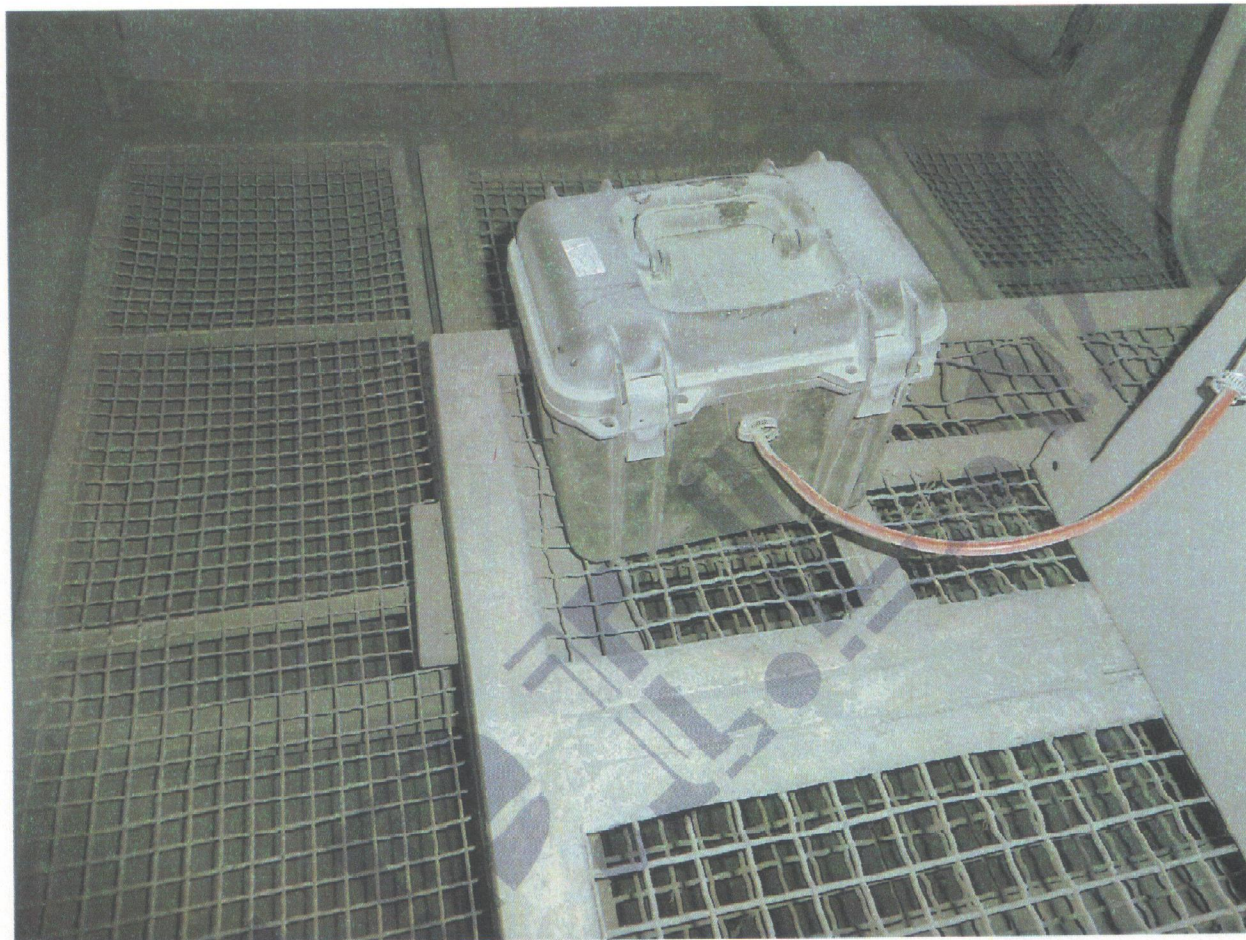
**Figure 1: EUT**

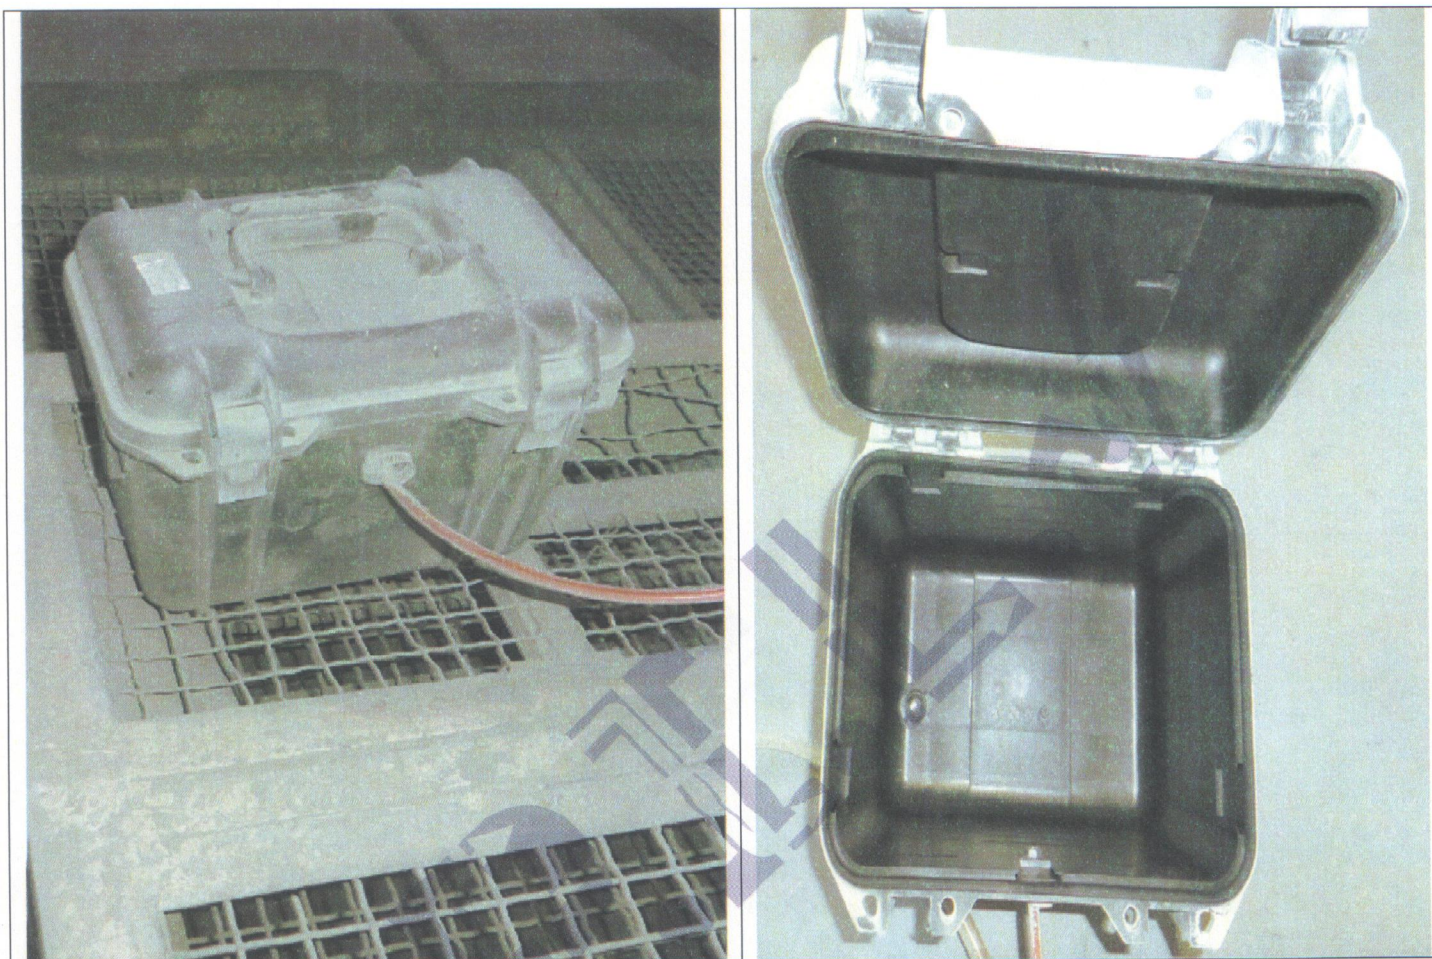
Figure 2: EUT after IP6X

The protection is satisfactory if no deposit of dust is observed inside the enclosure at the end of the test.

The test was done according to IEC 60529 and it passed the test.

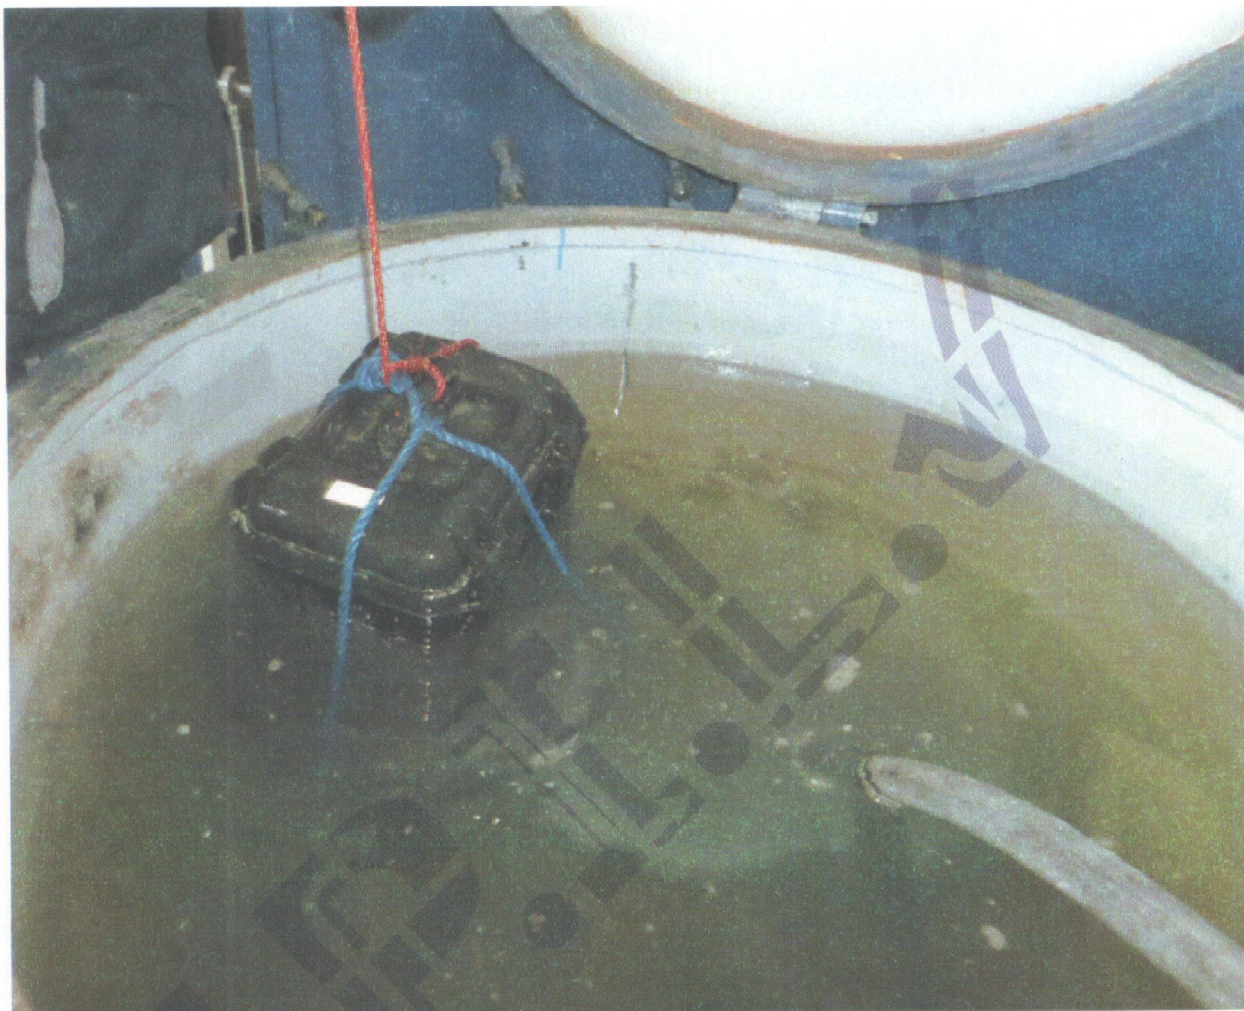
Figure 3: EUT under IPX7

- a) The lowest point of enclosures with a height less than 850 mm is located 1000 mm below the surface of the water
- b) The highest point of enclosures with a height equal to or greater than 850 mm is located 150 mm below the surface of the water
- c) The duration of the test is 30 min
- d) The water temperature does not differ from that of the equipment by more than 5K. However, a modified requirement maybe specified in the relevant product standard if the tests are to be made when the equipment is energized and/or its parts in motion.

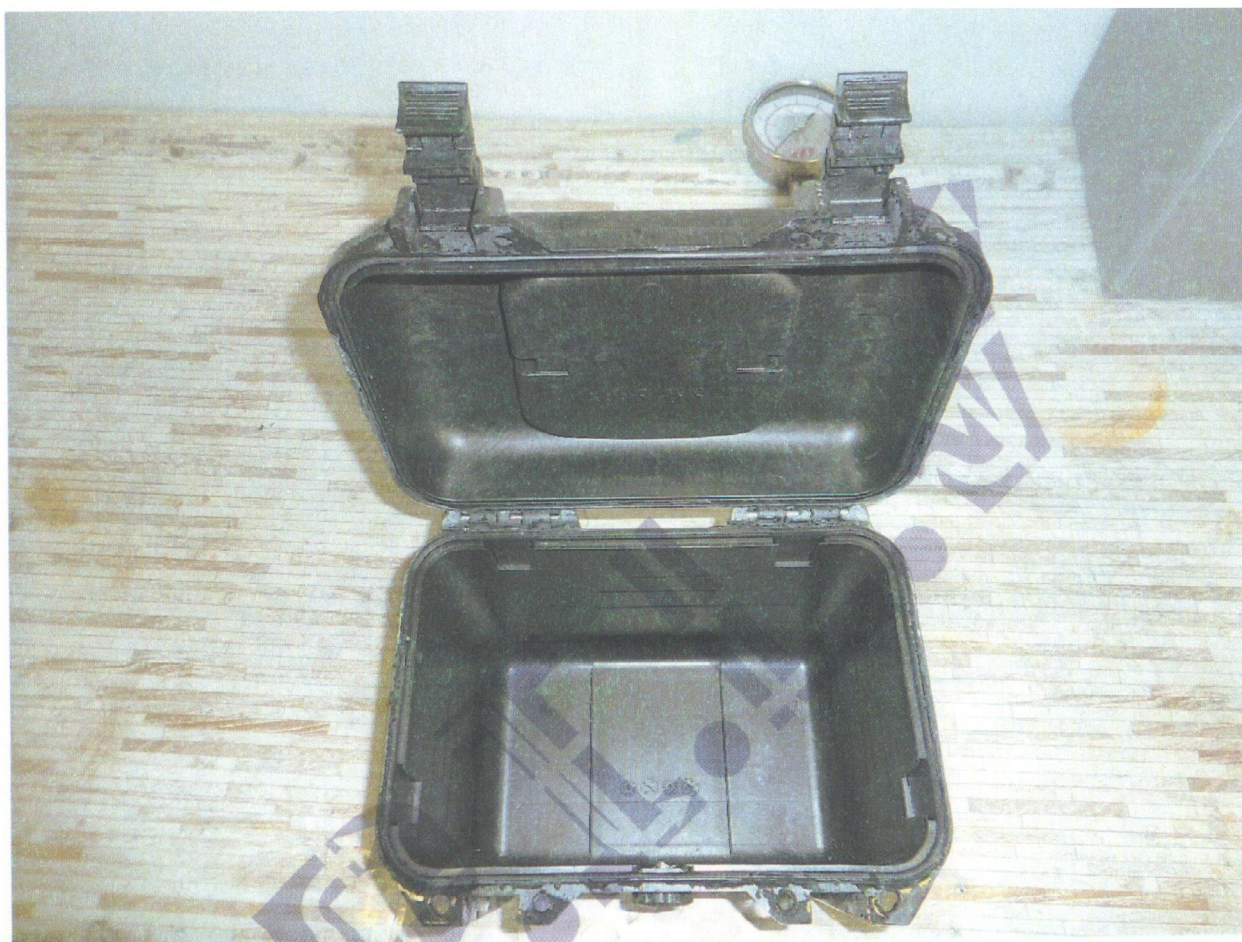
Figure 4: EUT after IPX7

After testing the EUT shall be inspected for ingress of water according to conditions that are specified in IEC 60529.

Test was done according to IEC 60529 and it passed the test.

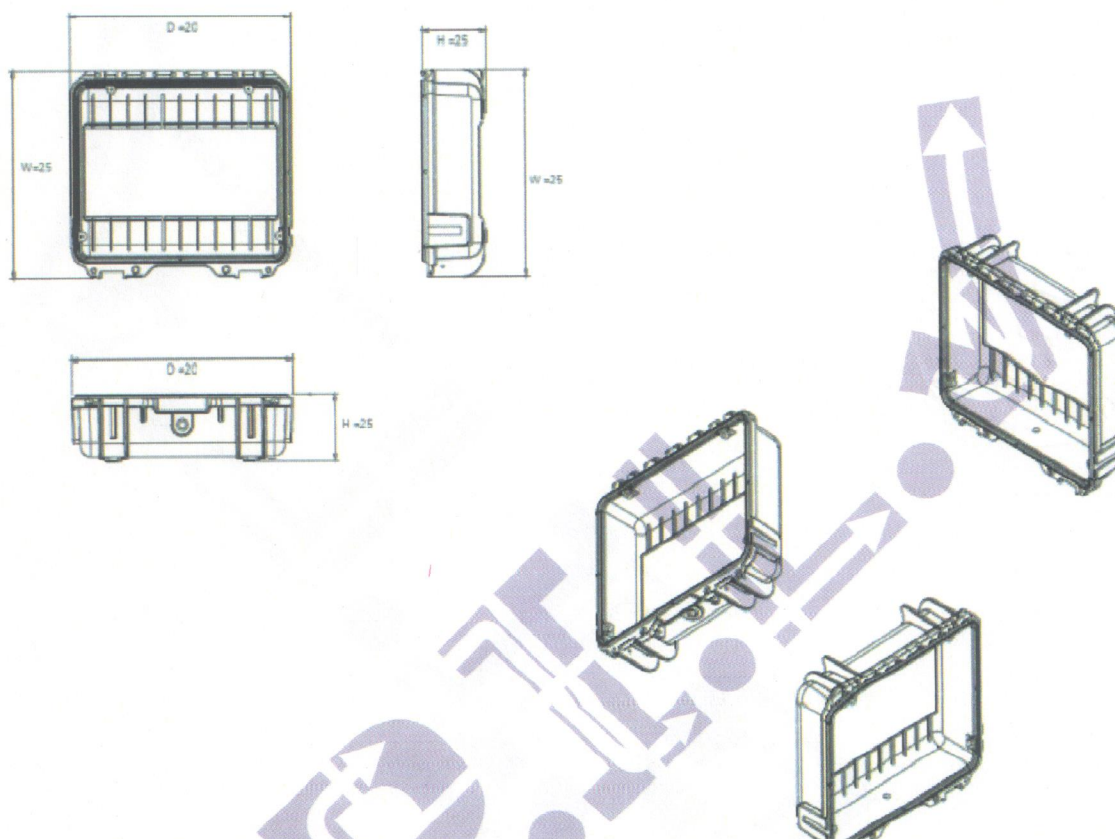
Figure 5: Dimension
